The January 17, 1994, Northridge Earthquake, California

H. S. Lew¹, Jim Cooper², Sam Hacopian³, Walter Hays⁴, and Mike Mahoney⁵

ABSTRACT

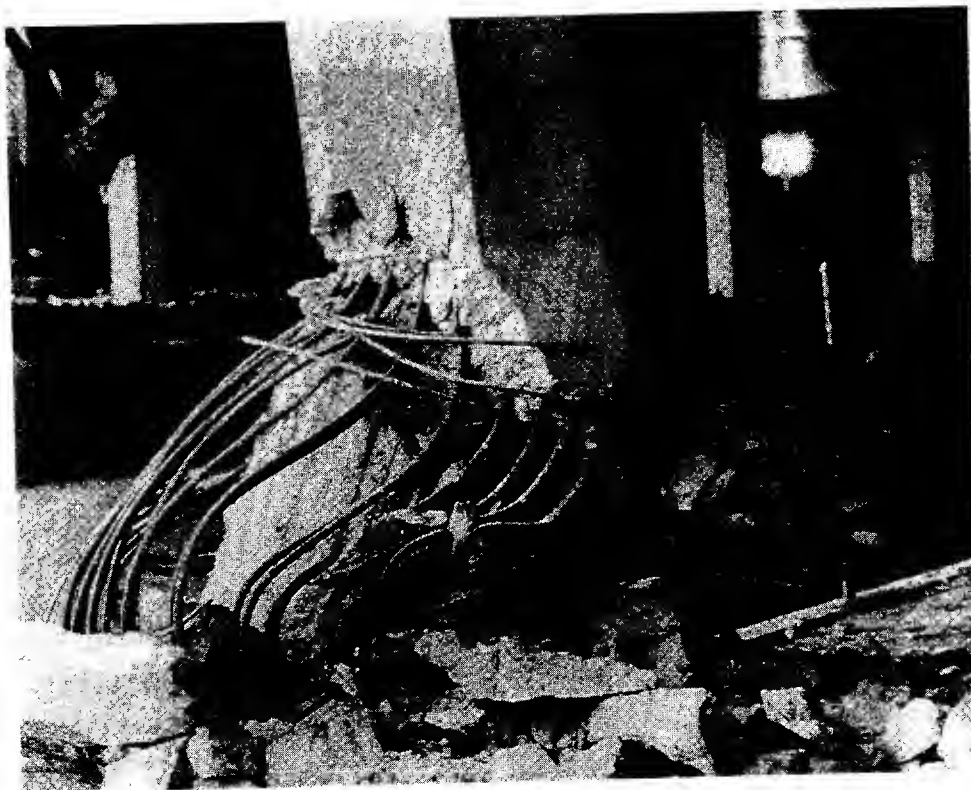
Figure 35 Damage to pier 3S-1 of State Route 118 at Bull Creek Canyon Channel, looking to the northwest

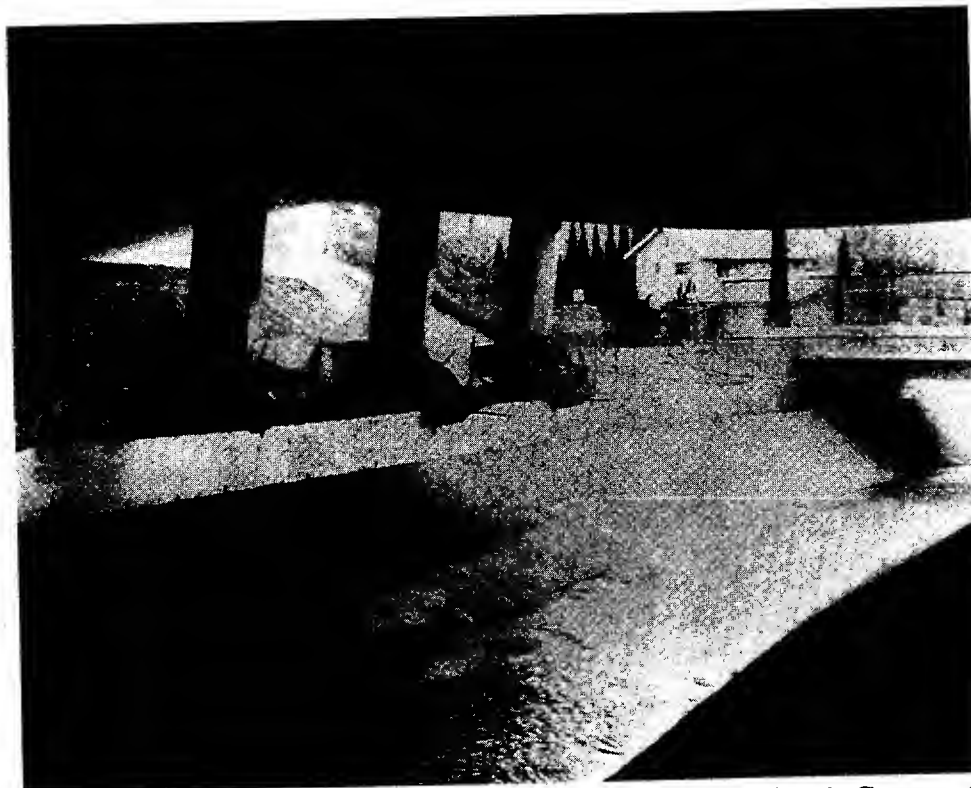
Figure 36 Damage to piers of Bent 3S of State Route 118 at Bull Creek Canyon Channel, looking to the southeast.

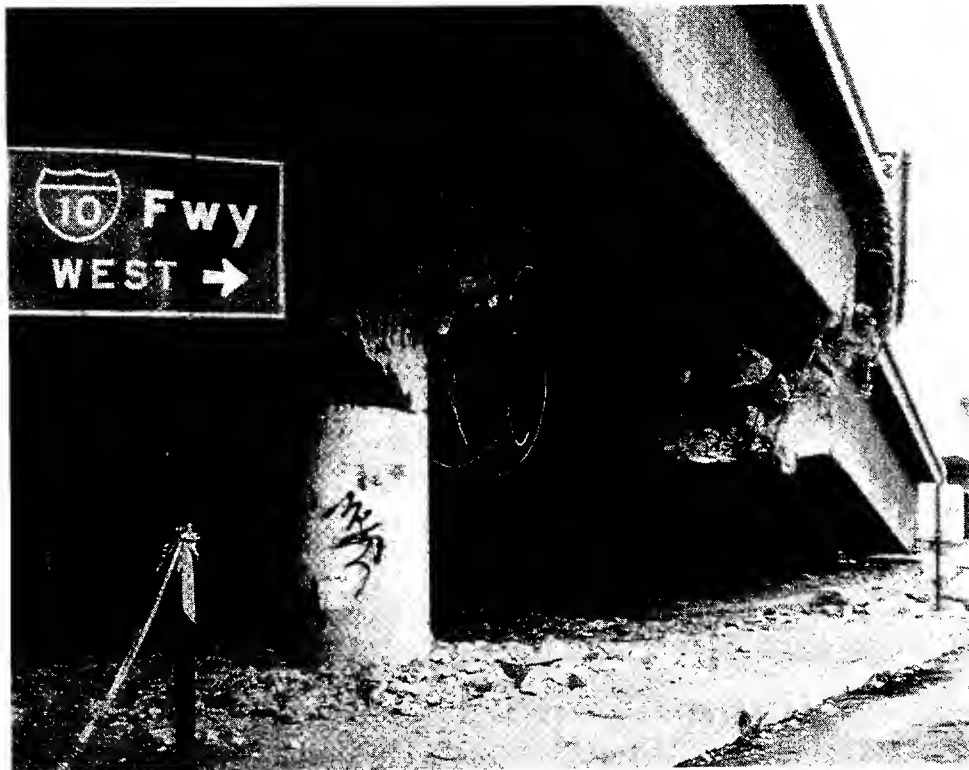
Figure 37 Collapsed westbound lane of I10 at Venice Blvd.; pier of Bent 7 in foreground

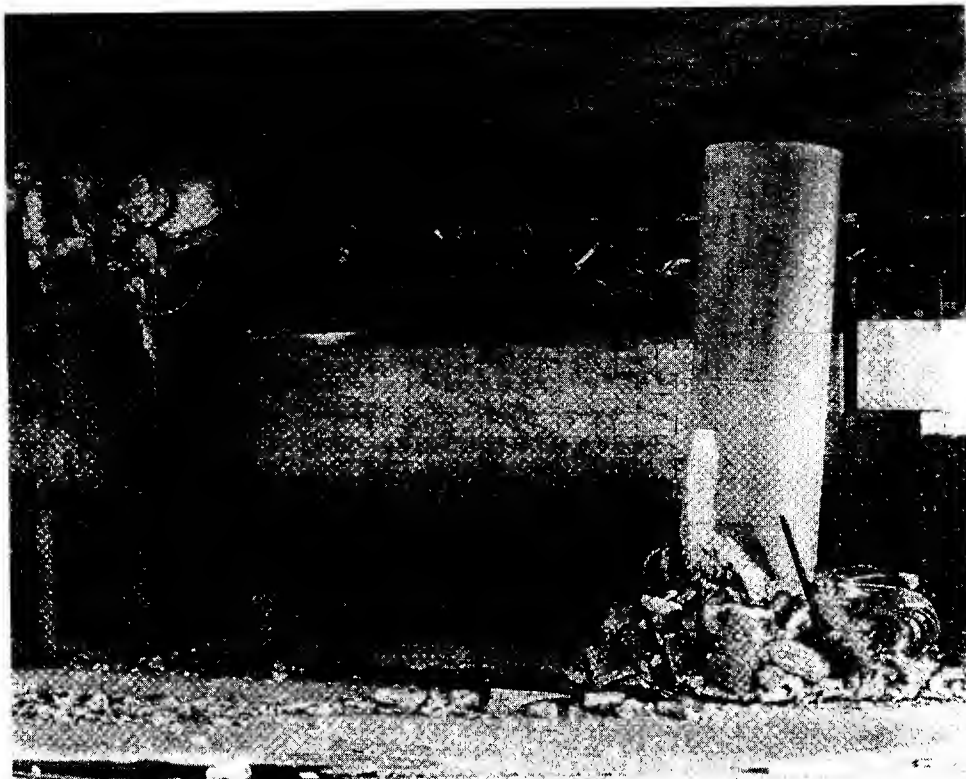
Figure 38 Failed piers in Bent 7 supporting westbound lane of I10 at Venice Blvd.

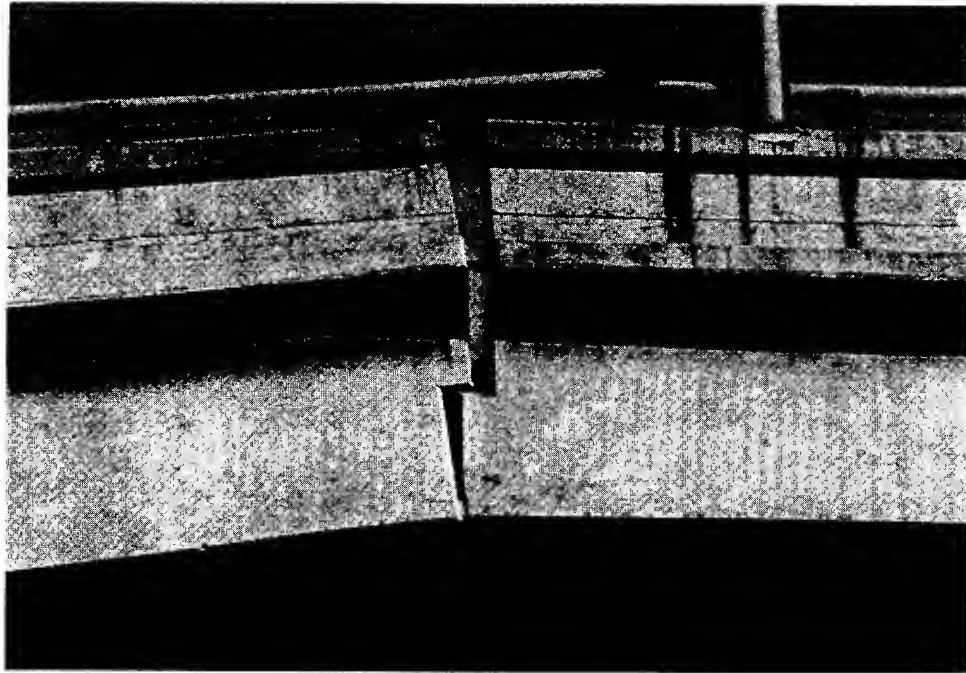
Figure 41 Hinge adjacent to Bent 4 of I 10 at Fairfax Ave.; cable restrainers prevented loss of support (Courtesy of EERC)

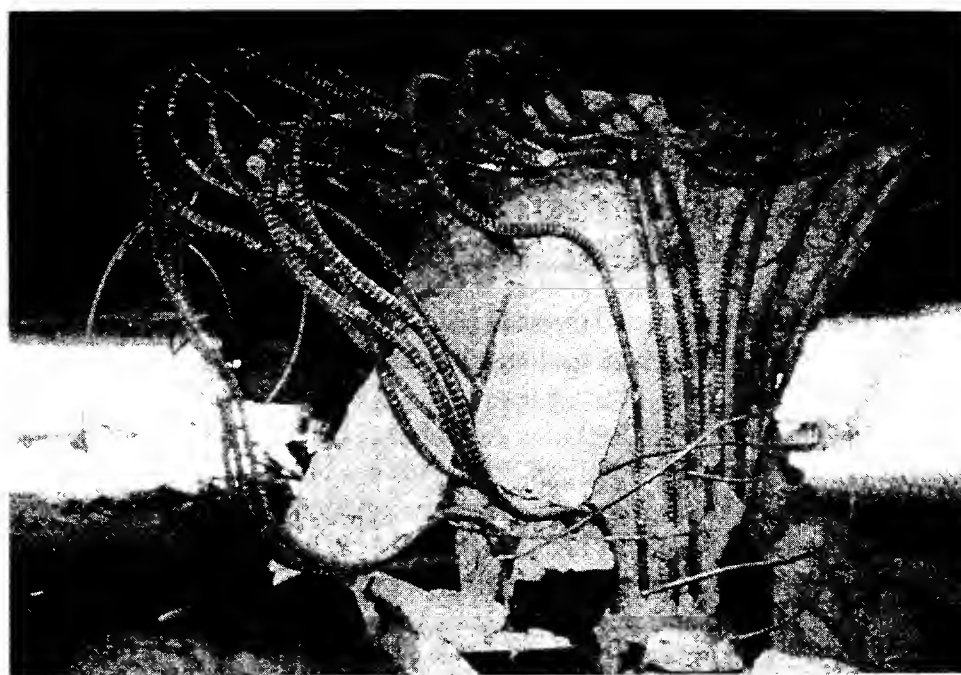
Figure 43 Failed column in Bent 3 of I10 at Fairfax Ave. (Courtesy of EERC)

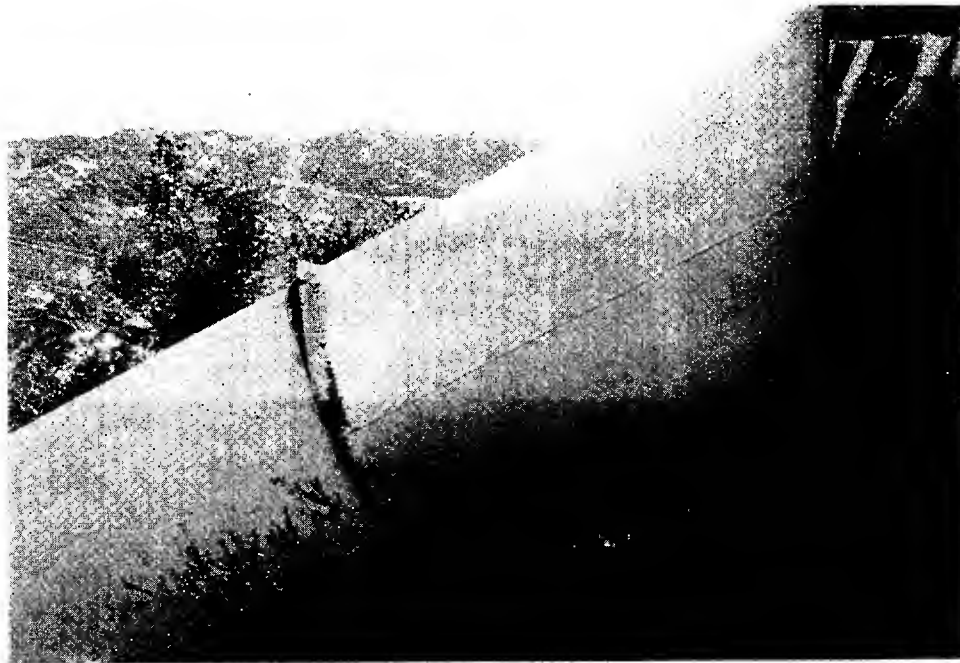
Figure 44 The steel pipeline at Terminal Hill separated from its supporting saddle at several places and pipe sections bulged at other locations along the alignment.

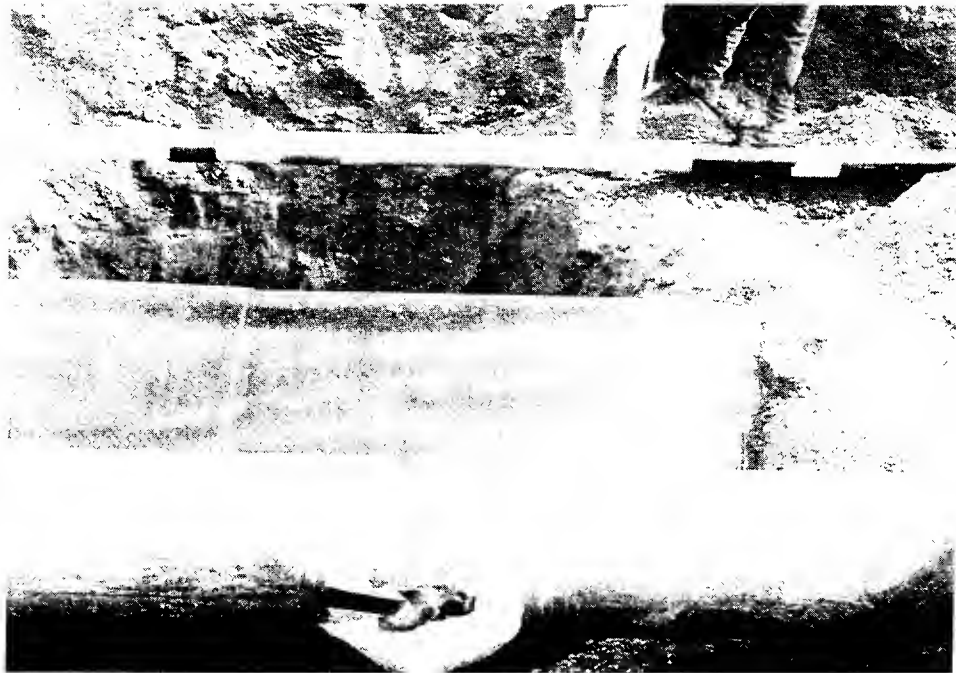
Figure 47 Ground contraction along Balboa Boulevard caused the rupture of a gas distribution line, the Rinaldi trunk water main, and a gas main.

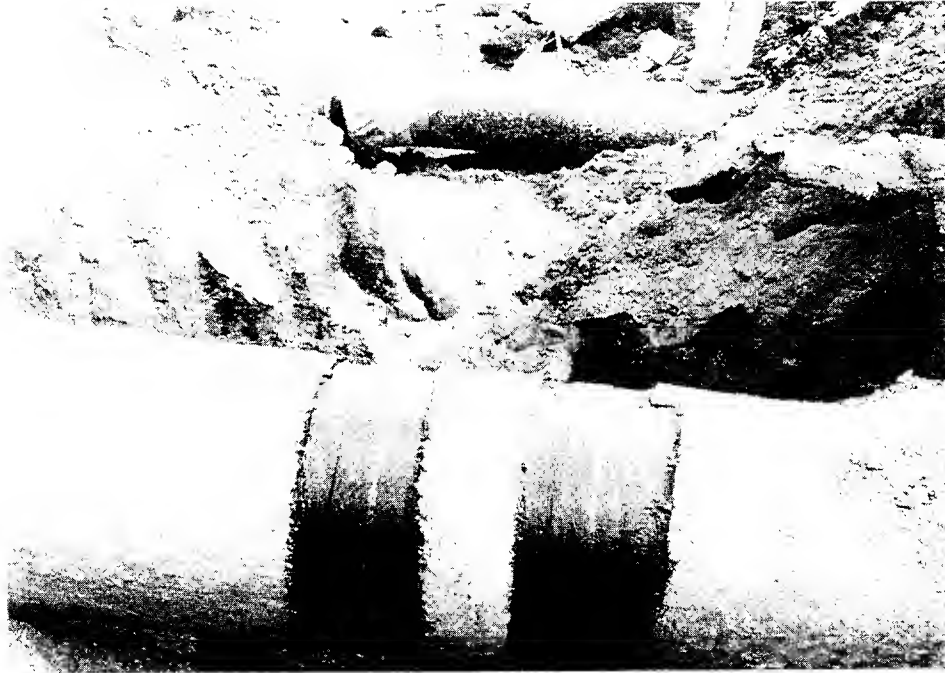
Figure 48 Ground extension along Balboa Boulevard resulted in the rupture of the same gas main and water main shown in Figure 47. The rupture of the gas main here caused a major fire that engulfed five houses.

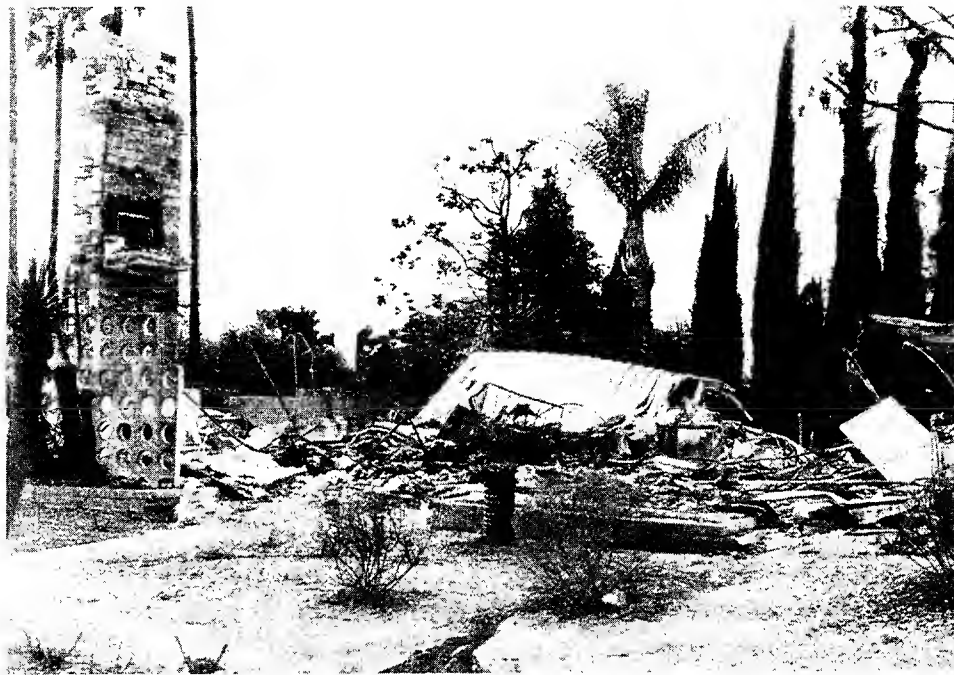
Figure 49 Houses destroyed by a fire resulting from the rupture of the 0.6-m gas main along Balboa Boulevard.

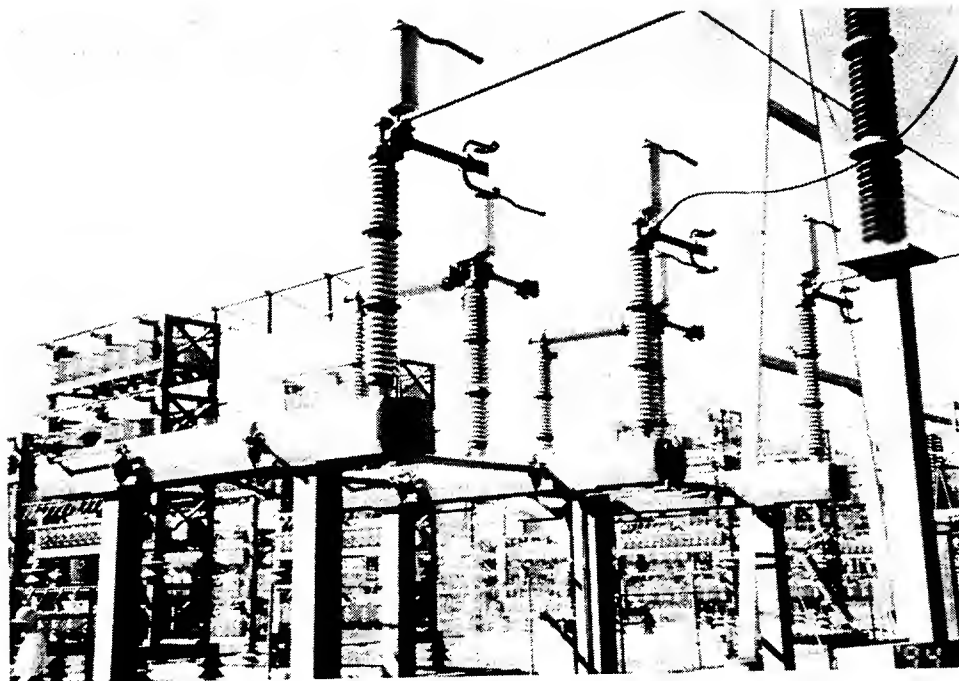
Figure 53 Most of the 230 kV circuit switchers (in the forefront) at the Sylmar substation were damaged. Most of the capacitor banks (in the background) performed well in this earthquake, whereas most collapsed during the 1971 quake. (Photo courtesy to Edward Matsuda of Pacific Gas and Electric Company.)

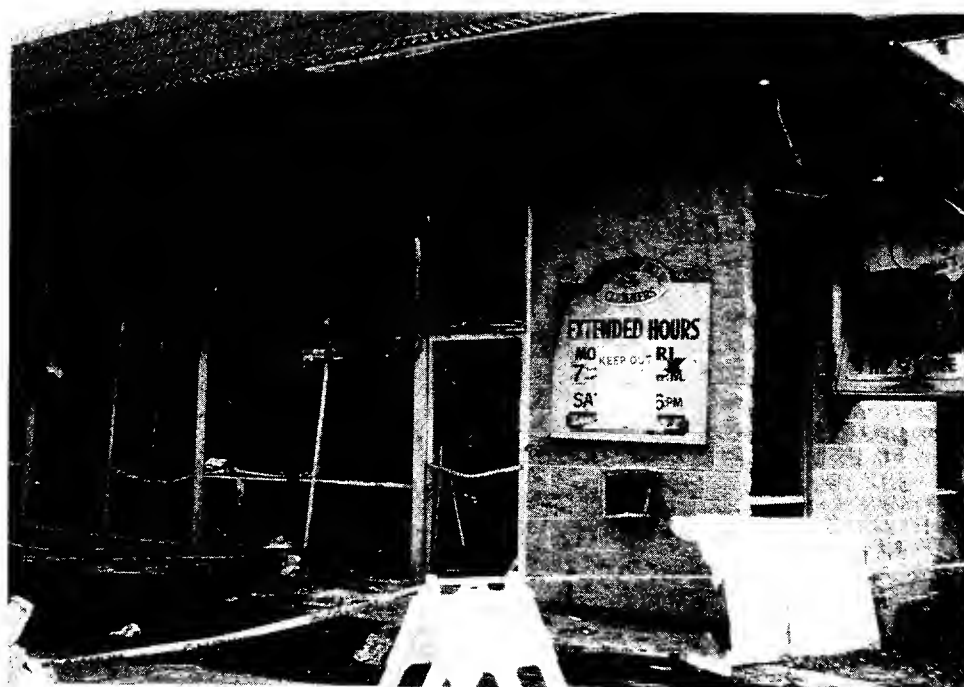
Figure 56 Fire damage in a single story commercial building.

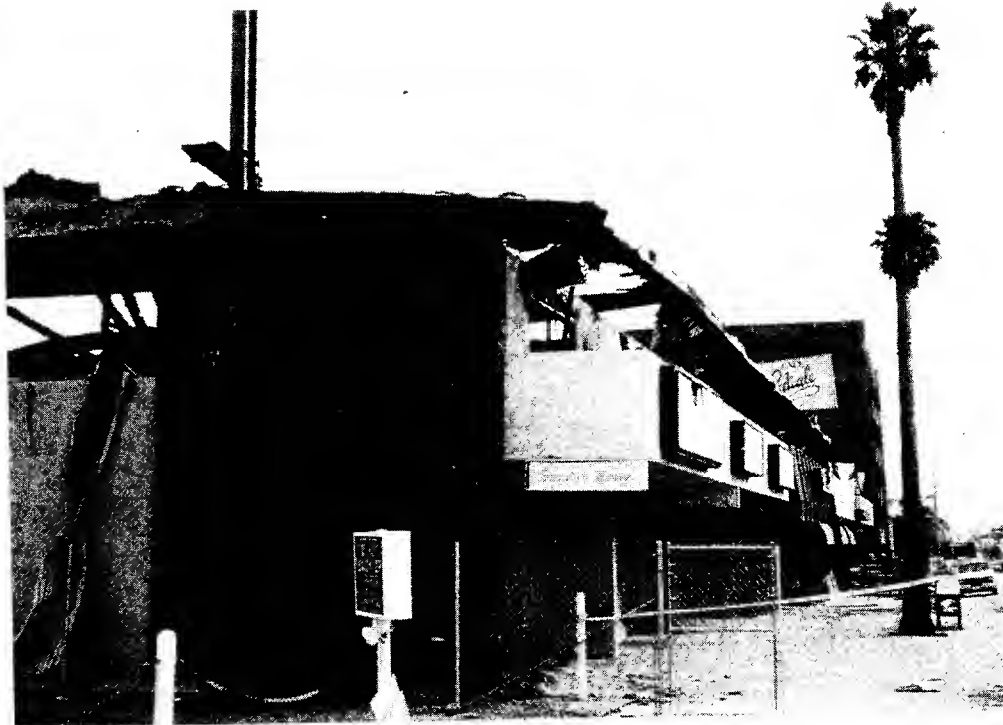
Figure 57 Fire damage in a two story commercial building.

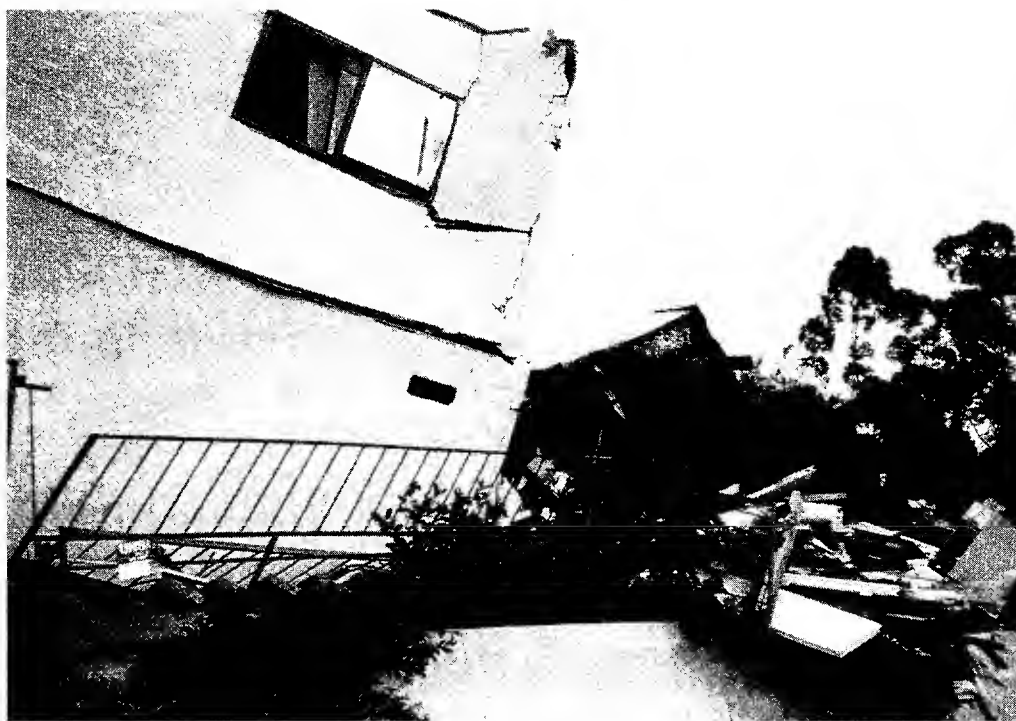
Figure 59 Partially collapsed apartment building with fire damage in the rear.

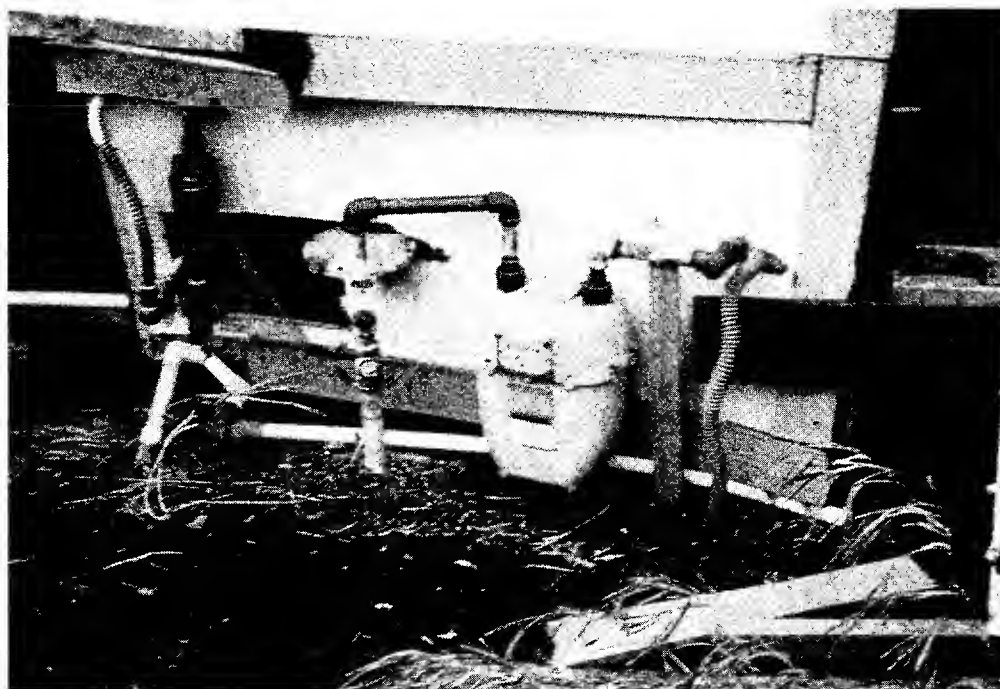
Figure 60 Damaged gas service in a manufactured housing development.

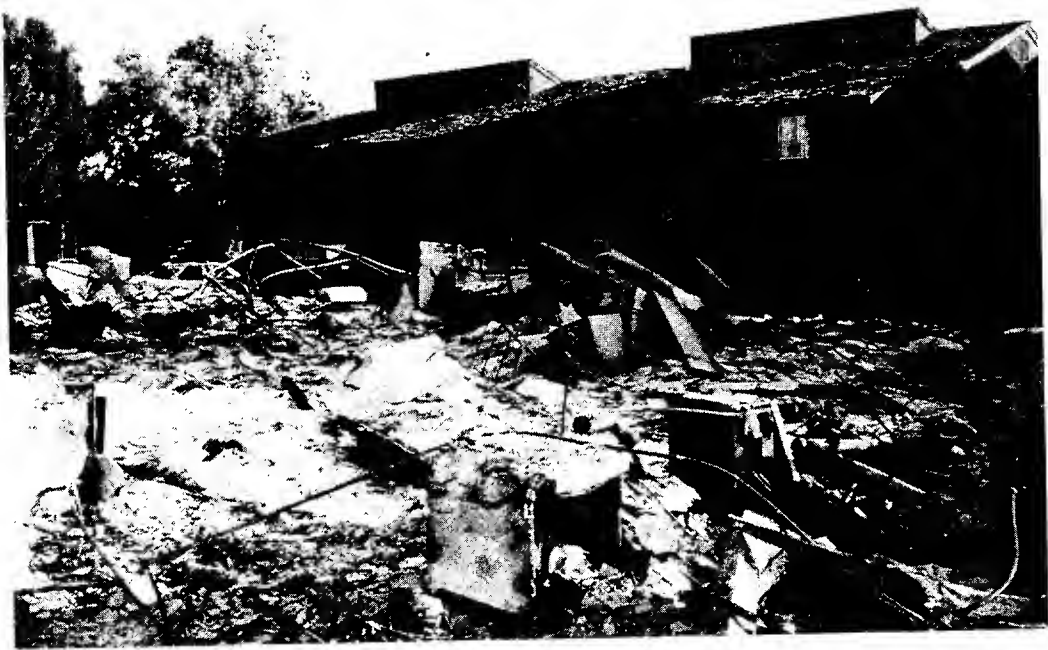
Figure 61 Multi-family residential building destroyed by fire.
